Manhole Inspection Summary

Manhole # S41AA_016MH

Insp Date: 1/30/09 1:37 PM

Location Address: **rear 1509 lester morten ct**

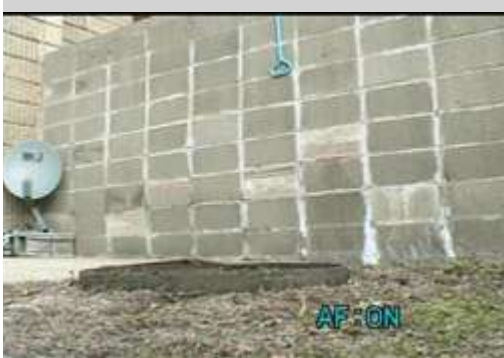
Miscellaneous

cover above grade 3 inches

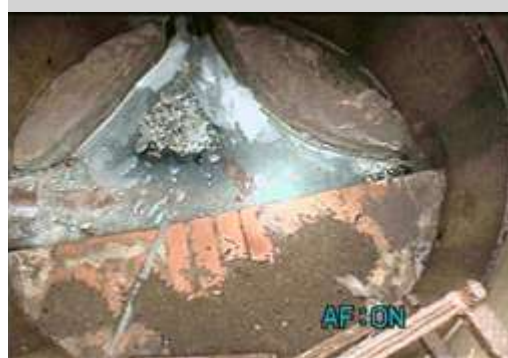
Defect

Condition: ☐ Sound ☐ Cracked ☐ Root Intrusion ☐ Deteriorated ☐ Leaks ☒ **Debris**

channel debris

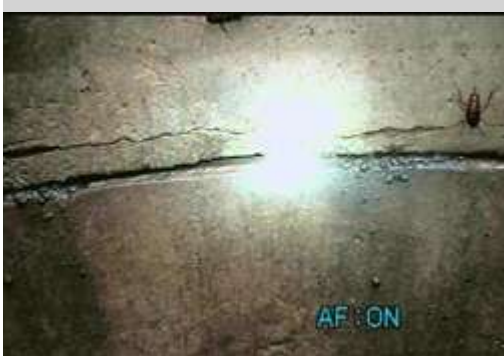
Defect 5

Condition: ☐ Sound ☒ **Cracked** ☐ Root Intrusion ☐ Loose Brick ☐ Deteriorated

corbel cracked

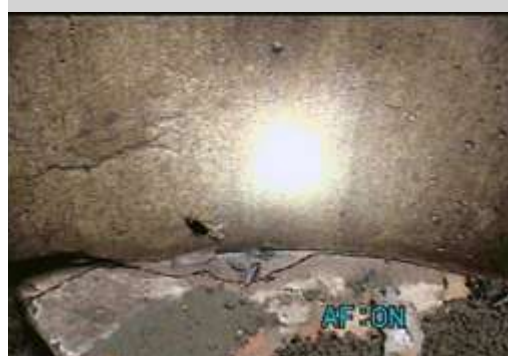
Defect 4

Condition: ☐ Sound ☒ **Cracked** ☐ Root Intrusion ☐ Deteriorated ☐ Leaks ☒ **Debris**

bench cracked

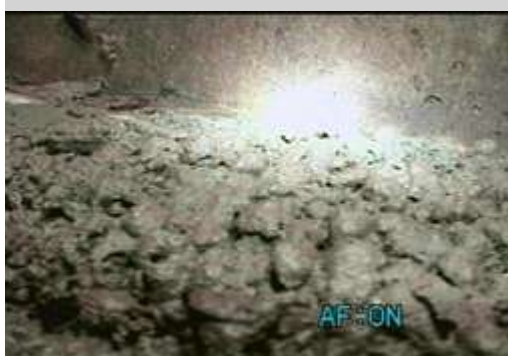
Defect 3

bench debris

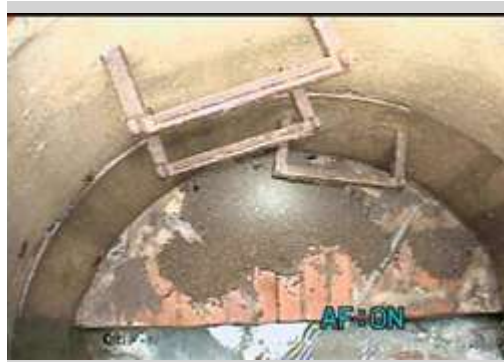
Defect 2

Count: **3** Missing: **0** ☒ **Corroded**

steps corroded
